Manhole Inspection Summary

Manhole # S37WW_035MH

Insp Date: 1/10/07 11:03 AM

Location Address: **704 MONTPELIER ST**

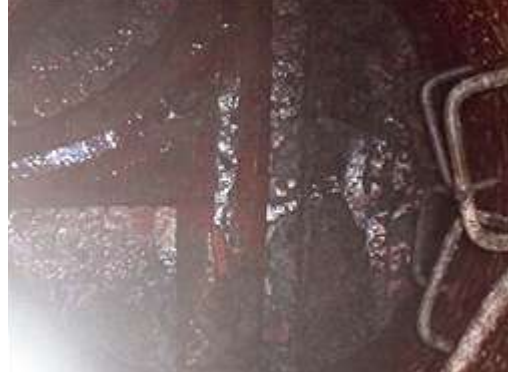
Top View

Corroded steps. Evidence of surcharge - Bench debris.

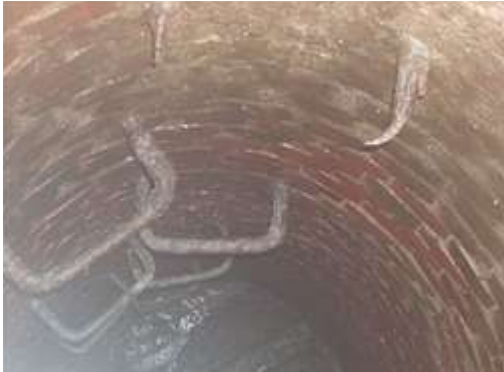
Defect

Barrel infiltration. Corroded and missing steps.

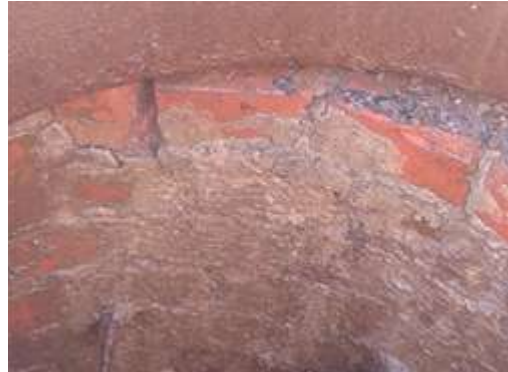
Defect

Frame leaks. Frame offset. Adjustment deterioration and infiltration.

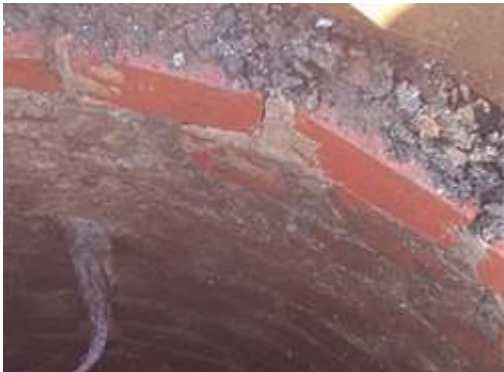
Defect

Frame leaks. Frame offset. Adjustment infiltration.

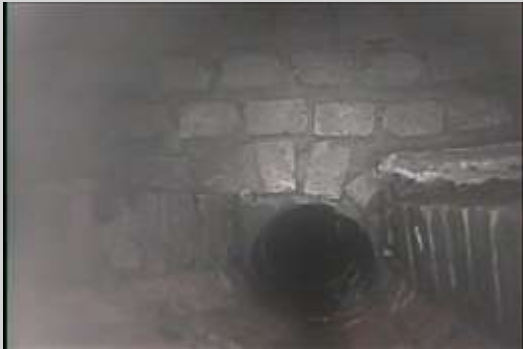
8 in. Circular Gravity Sewer Pipe Out @ 12 O'Clock

Infiltration: **Evidence** Pipe Seal Cond: **Unknown**

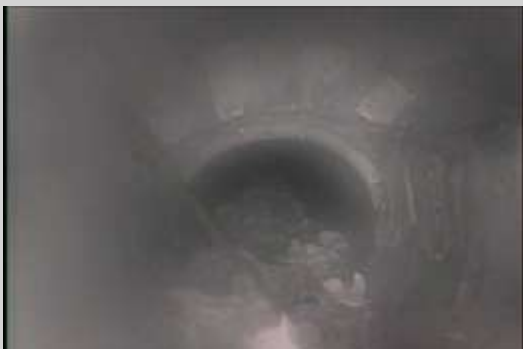
8 in. Circular Gravity Sewer Pipe In @ 6 O'Clock

Deposits: ☐ None ☒ **Mud** ☐ Sludge ☒ **Debris** ☐ Grease

Silt Depth: **2** (in.) Deposits Extent: **Light**
